## PROJECT PROFILE

*Entire GEO flooring system  
refurbished to withstand  
chemical exposure and  
thermal shock*

#### **GEO Specialty Chemicals**

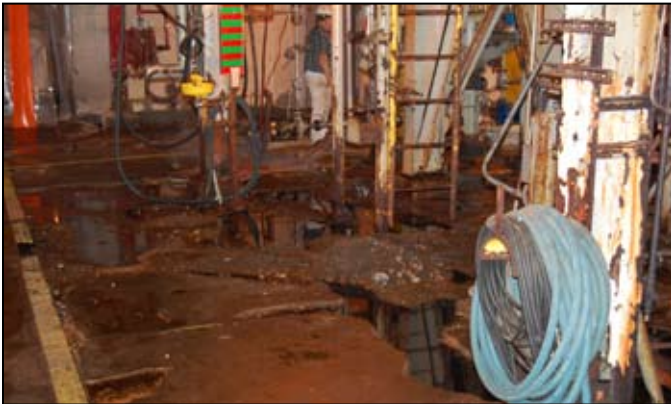
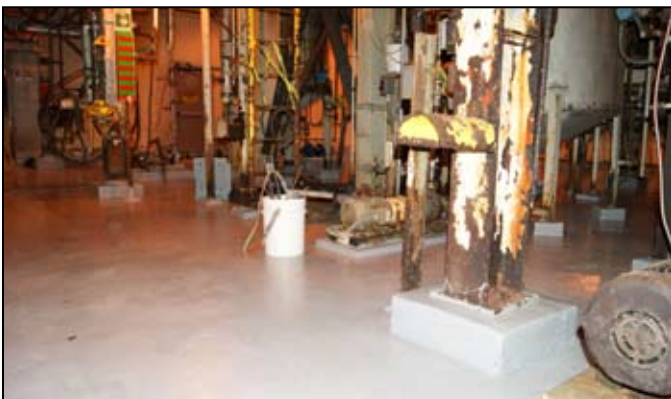
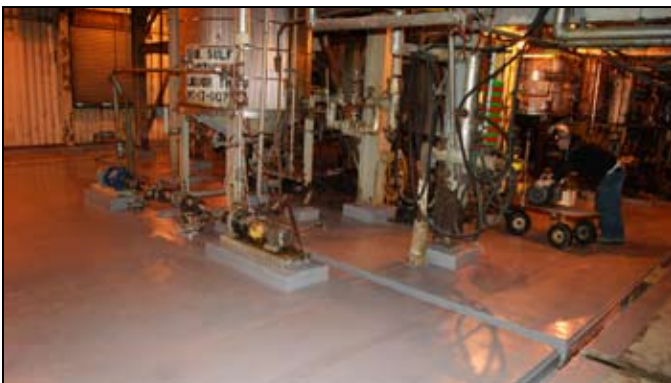
GEO Specialty Chemicals had approximately 3,000 SF of badly damaged concrete due to their chemical process. Not only was the concrete corroded in some areas and heaved in others, all the pump pedestals were damaged, and the trench drains no longer functioned.

- Concrete needed to be brought back to a level surface which required rebuilding the entire substrate.
- All the pump pedestals and trench drains needed to be reformed to the original state.
- A chemical resistant coating needed to be applied throughout to protect the foundation.

- **SIKA 1000**  
Rapid Hardening Repair Mortar
- **TuffRez® 200 CR**  
Epoxy Novolac Topping Binder | Chemical Resistant
- **PolySpec® 300 EX Primer**  
Epoxy Performance Primer for Concrete
- **NovoRez® 351**  
Coating | Acid Resistant
